# Thermopile Support: FAQs, Troubleshooting, Care & Maintenance

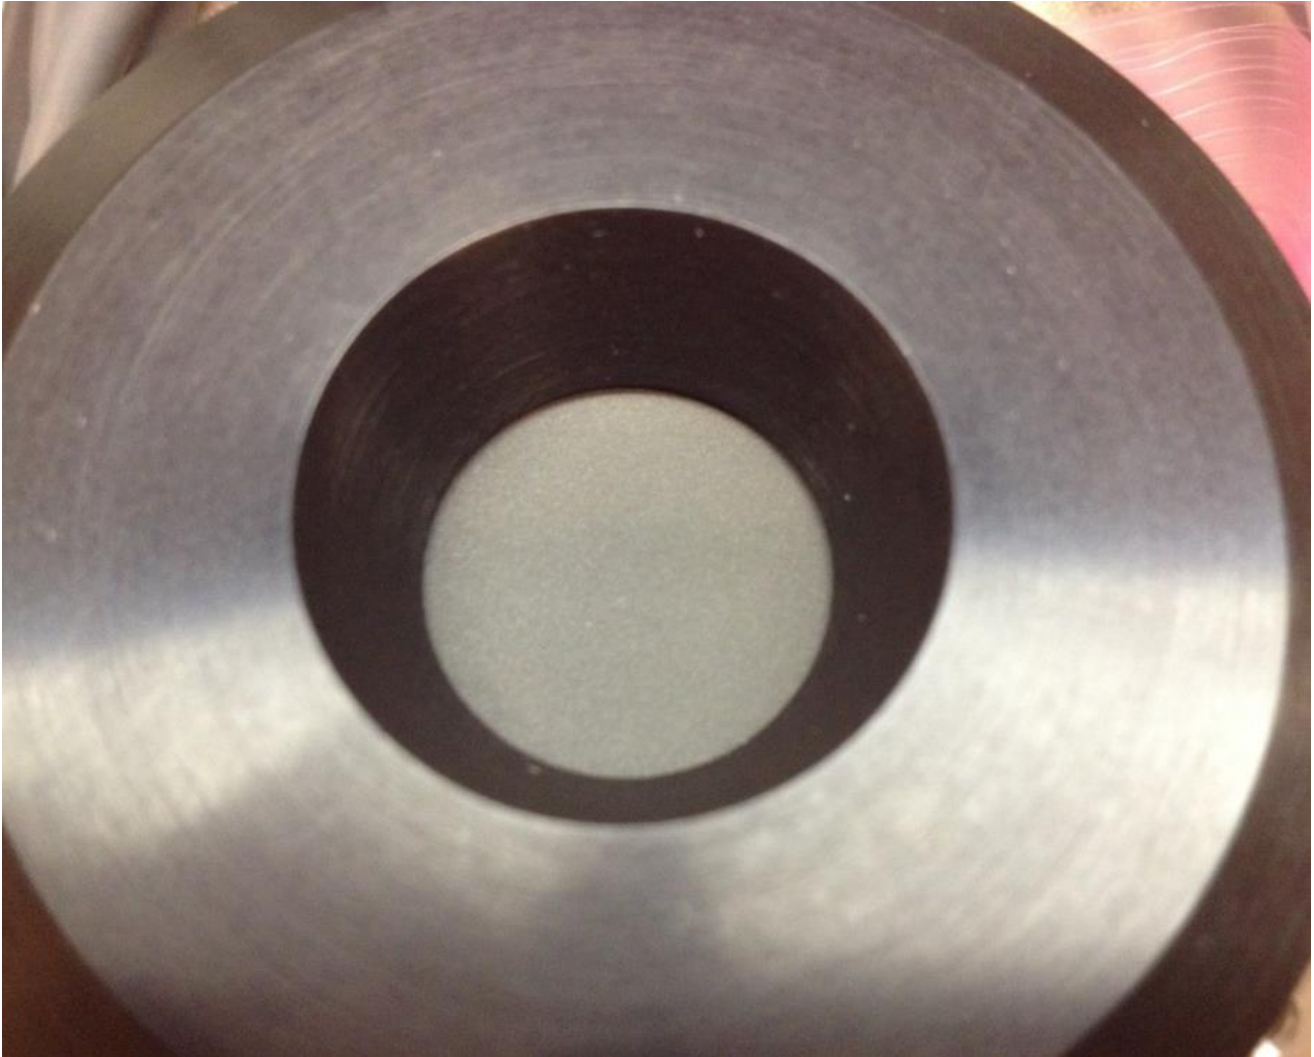
***Figure 1: Healthy Thermopile Sensor with No Damage***

The absorbing disk on the sensor is a uniform flat gray color with no discolorations or burn marks on it. A sensor in this condition will typically not have any problems with the thermopile disk itself.

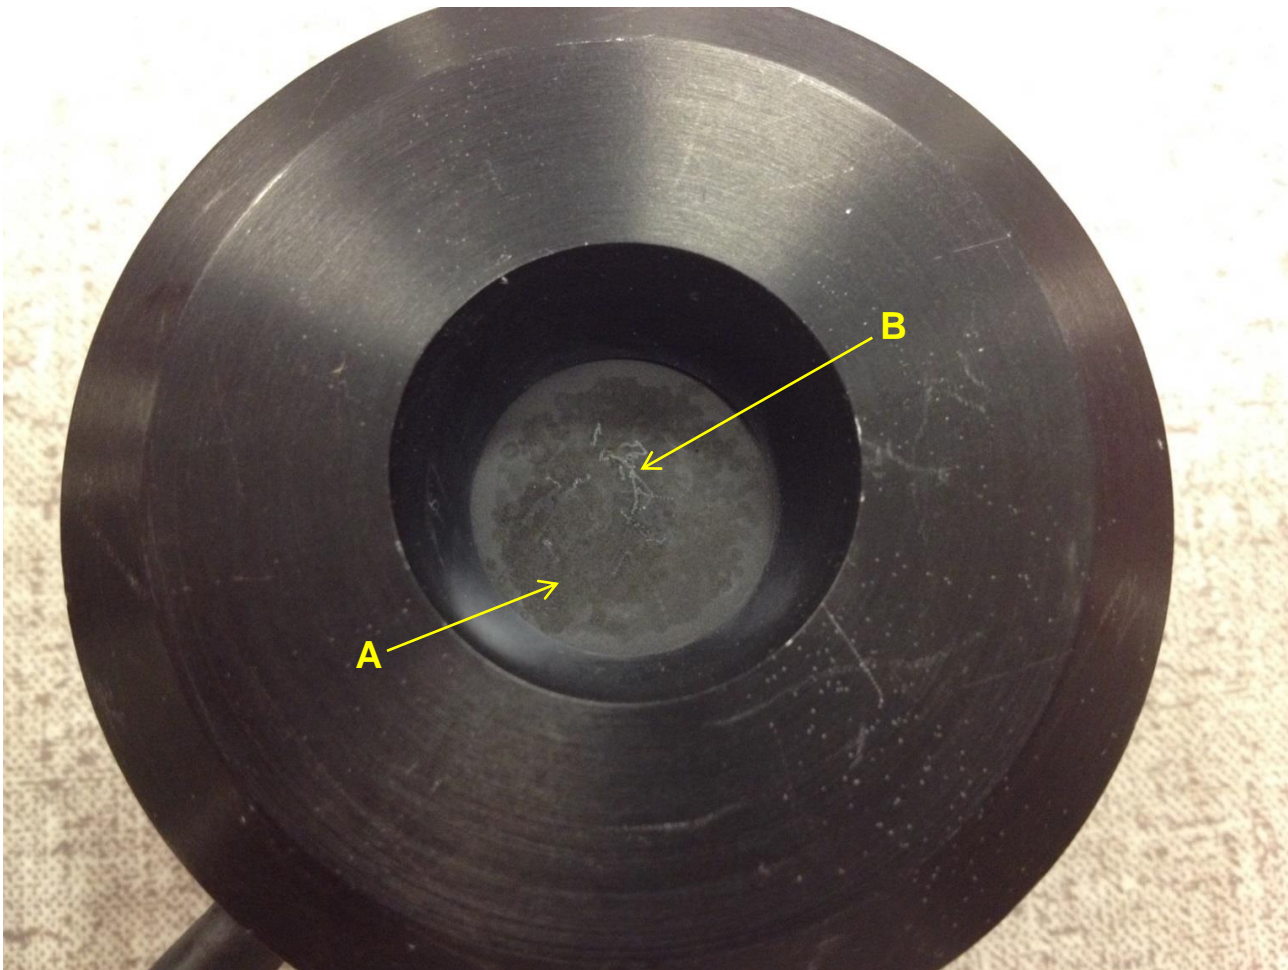
**Figure 2: Discoloration and Scratches While Moving the Sensor during Measurement**

- A. The dark discolorations that cover the entire sensor area are a collection of smaller circular marks caused by using a power density that is slightly higher than recommended while moving the beam around to different areas on the sensor disk.

Slight discolorations (either slightly lighter or slightly darker marks) should not cause sensor performance issues. However, the circular marks pictured above are darker than the flat gray color of a healthy sensor surface, which indicate that the coating is starting to burn. In this specific area, the damage has not ablated or melted the coating of the sensor. However, the dark discolorations indicate the coating is starting to burn. We recommend changing the absorbing disk before major damage is caused to the sensor.

- B. The marks that resemble squiggly scratches are areas where the coating has been ablated. This is the result of using a tightly focused beam and moving the sensor around in the beam path during a measurement. It is evident the coating is missing due to the exposed metallic color within the marks.

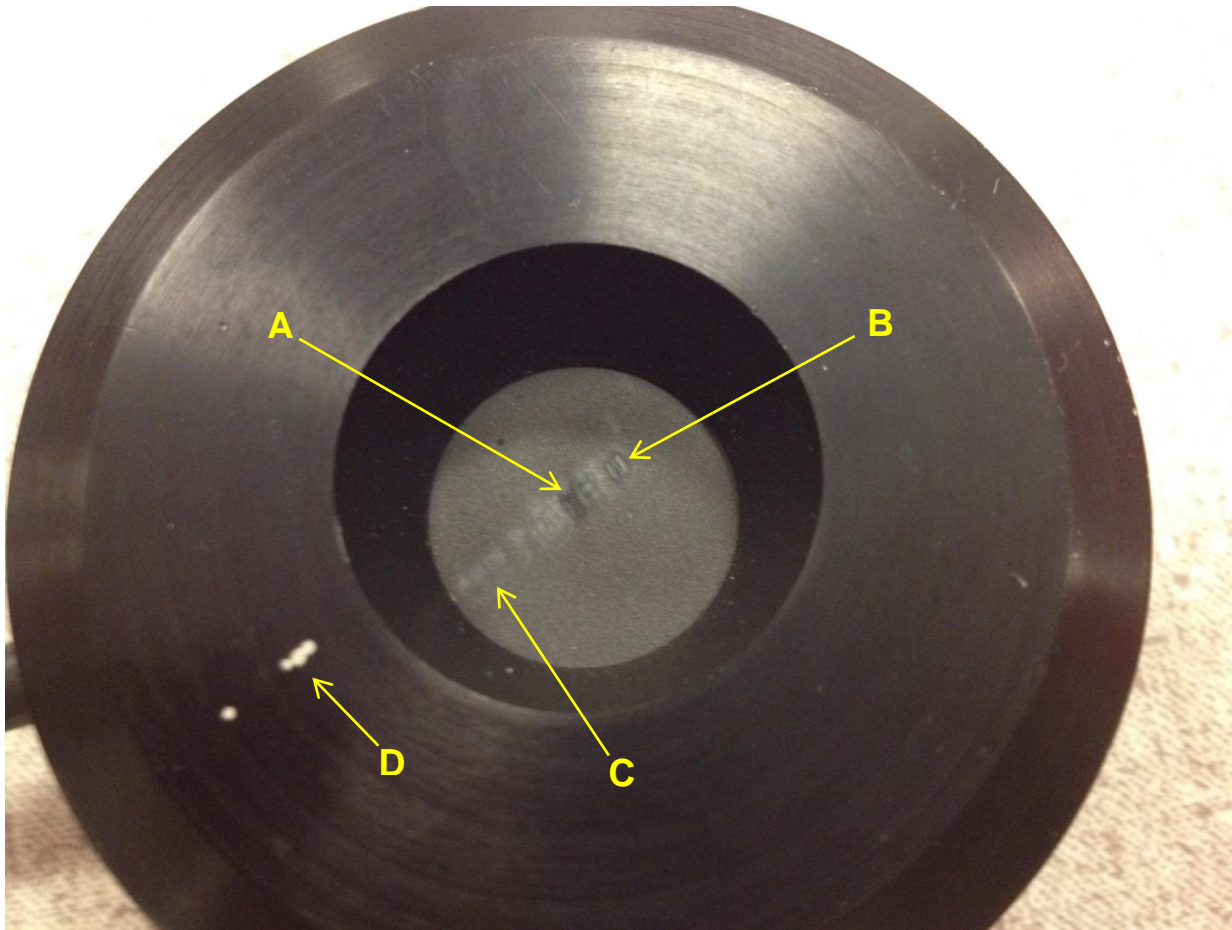
**Figure 3: Thermopile near Its Damage Threshold While Moving Sensor during Measurement**

- A. The dark marks indicate the coating is beginning to burn.
- B. Small metallic spots surrounded by a darker ring indicate the coating has been ablated

- C. The slightly lighter gray spots are on the boarder of what we consider damage. This is what happens if the sensor is used very near its damage threshold. The coating discoloration typically does not cause performance problems. If you continue to see similar discoloration or if the discoloration darkens, it is necessary to reevaluate the beam size before continued use. In this particular figure we recommend replacing the disk due to the presence of both dark spots and the ablated spots. The linear pattern of marks across this sensor surface appears to indicate that the sensor was moved through the beam path while the power density was fairly high.

- D. Ablation on the anodized housing of the sensor does not cause any performance problems with the product, but could be another indication that the power density is too high and that the sensor has most likely been placed too close to the focal point in the beam path.

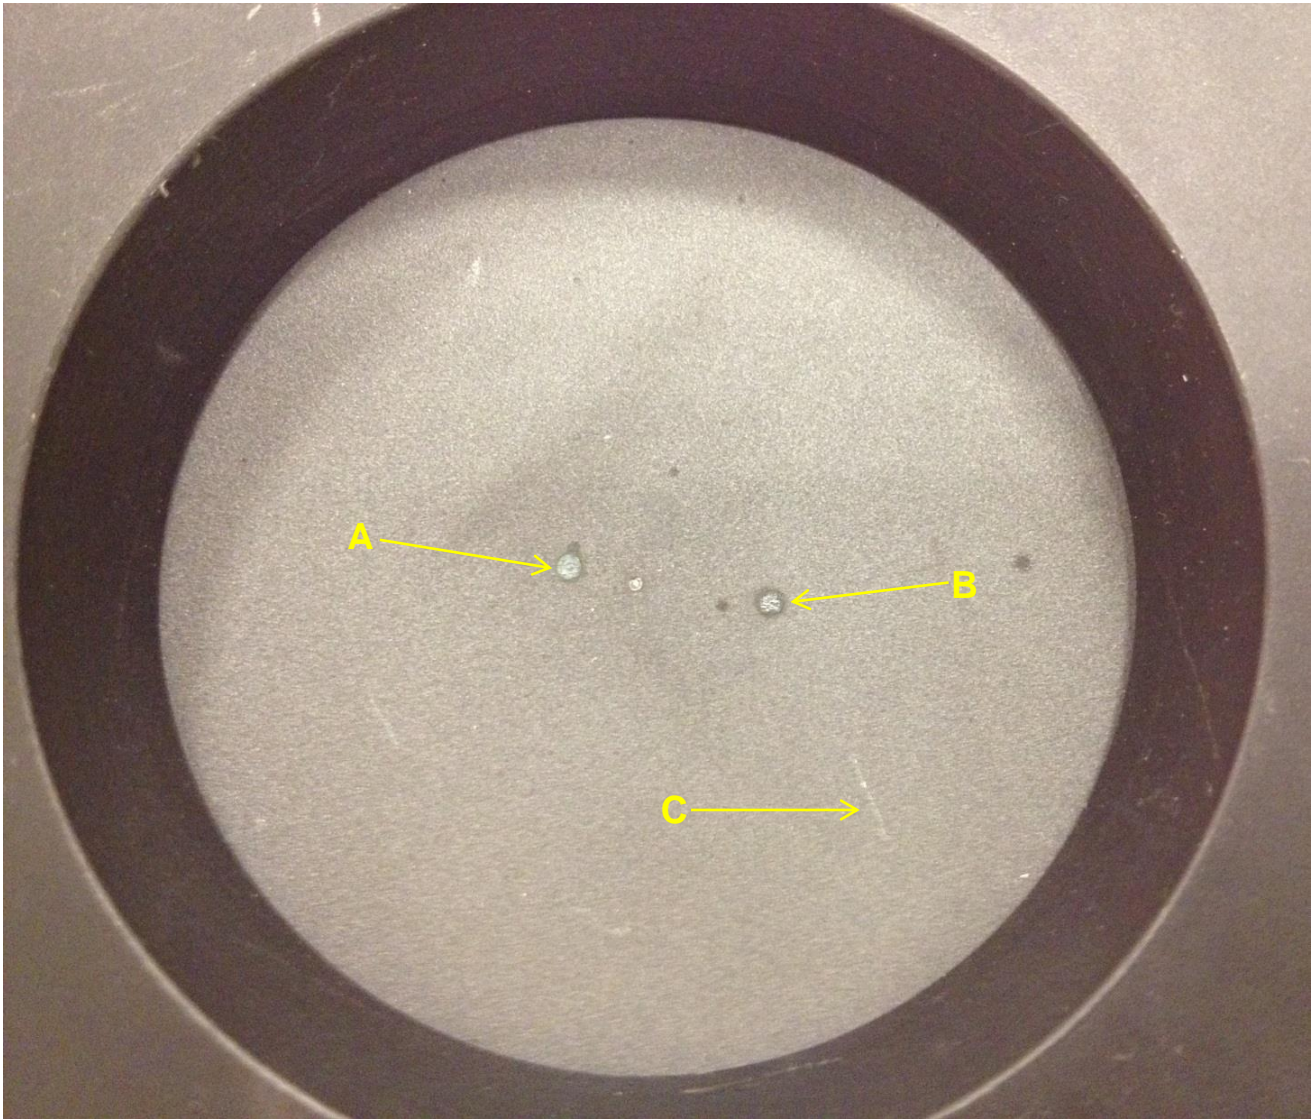
**Figure 4: Thermopile Damage as the Result of Too High of a Power Density**

This is a common example of what happens when too small of a beam size is used. The power density in these small circular spots has zapped the coating right off the sensor.

- A. The green color within the circular spot indicates that the sensor coating has started to melt at that spot. The presence of the color green on the sensor surface represents relatively significant damage due to a melted coating.
- B. Within this spot, metallic color is surrounded by a darker ring which means the coating has been ablated and there is charring around the ablation. This is caused by too high of a power density hitting the sensor surface. The sensor disk must be replaced in order to recalibrate it.

- C. Small scratches are caused by something coming in physical contact with the sensor surface. For example, a tool could have hit the sensor surface while being put away, or perhaps the connector on the sensor's cable accidentally rubbed across the sensor surface. These small scratches are usually on the very surface of the sensor and will not cause major problems unless metal can be seen within the scratches of the coating. Typically, no replacement of the thermopile disk is required unless there are a number of scratches and the scratches are deep enough to reveal metal.

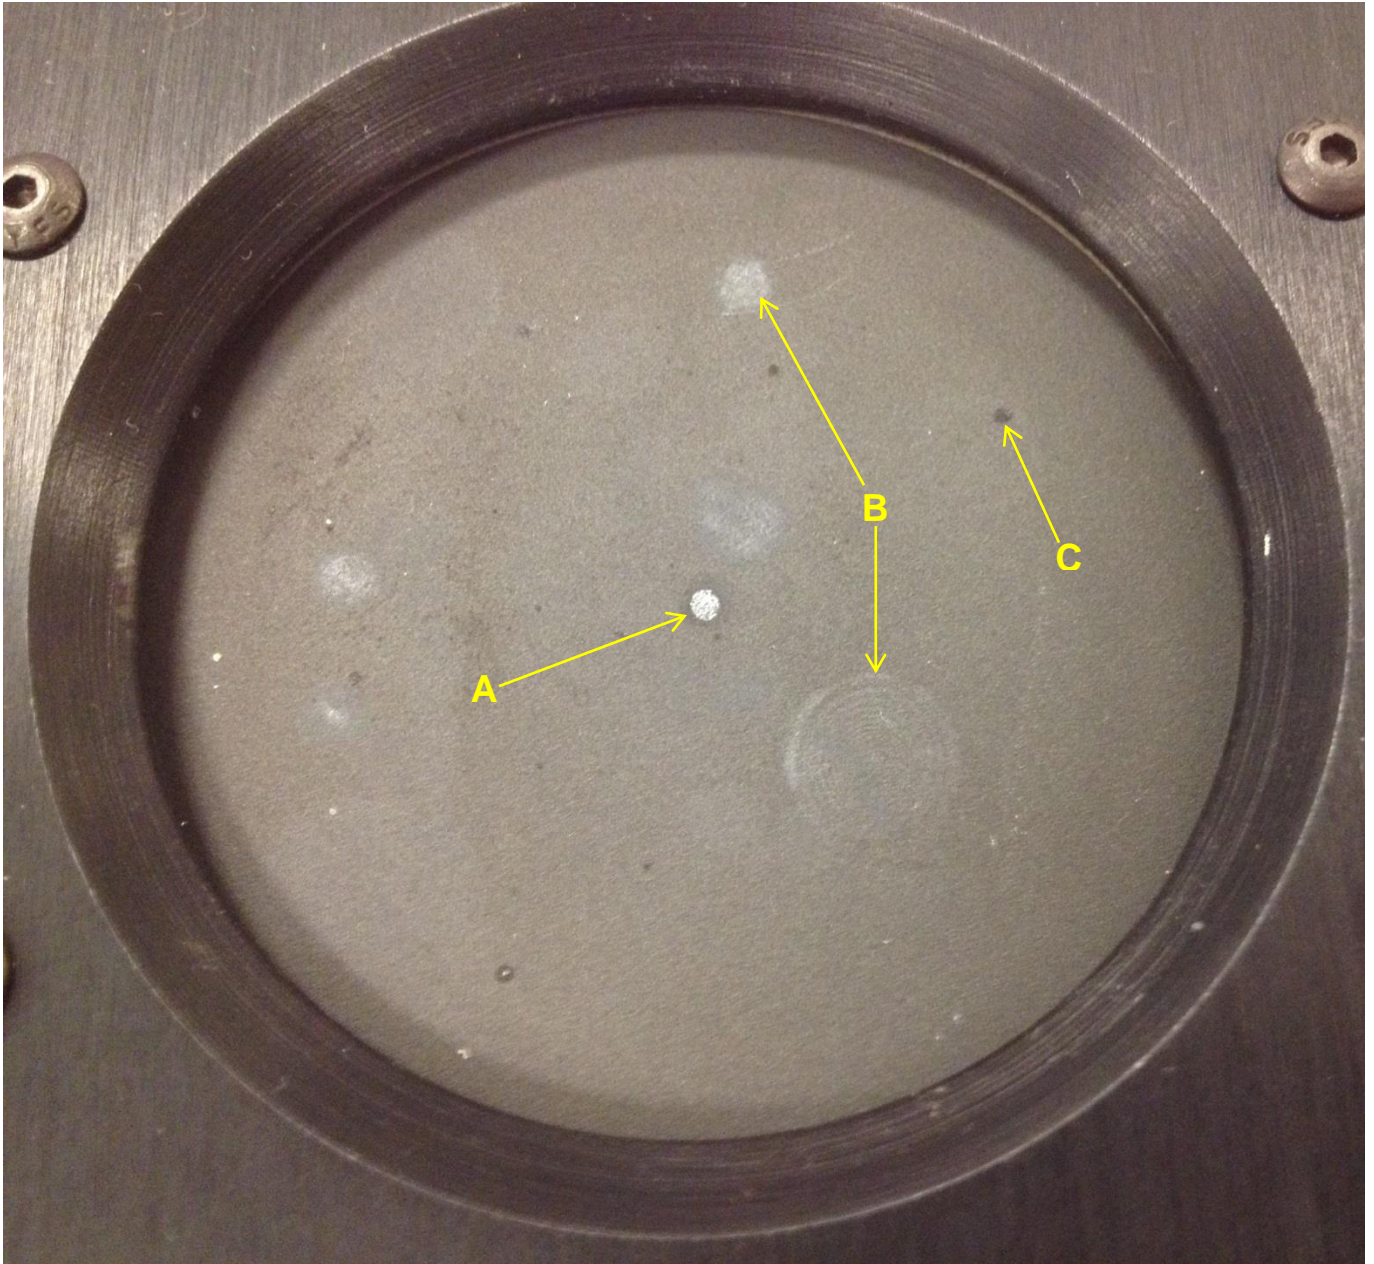
**Figure 5: Severe Thermopile Damage Caused by Too High of a Power Density**

- A. This is the most serious damaged spot within this figure caused by too high of a power density. The coating has been ablated and there is metal visible. The appearance of this spot would prompt a recommendation of replacing the sensor disk during repair or recalibration. Due to the spot's central location in this particular figure, the sensor cannot be recalibrated until the disk is replaced.

- B. There are a number of lighter colored marks on the sensor surface that appear to have been caused by a laser beam. These spots are slight discolorations in the coating and may or may not prompt a disk replacement depending on how many there are and their location on the sensor surface. Generally, if there are one or two slightly discolored spots like this, it will not greatly affect the sensor performance and the sensor can be recalibrated to account for any slight changes in absorption due to spots like these. If there are quite a few spots, to the point where the overall absorption of the sensor is compromised, it may prompt recommending a disk replacement.

- C. There are a few of these small black marks on this sensor which indicate some type of burn mark. It's possible a very small beam caused this type of burn. Or it could be that some piece of debris (maybe a piece of dirt or a drop of grease) landed on the sensor at some point. The next time a laser beam hit that spot, it may have burned the debris onto the sensor coating. Spots like this can burn in the laser beam even if the power density isn't real high. A few small spots like this on a sensor may not warrant replacing the disk. But larger spots or large collections of these spots could prompt replacing the disk.

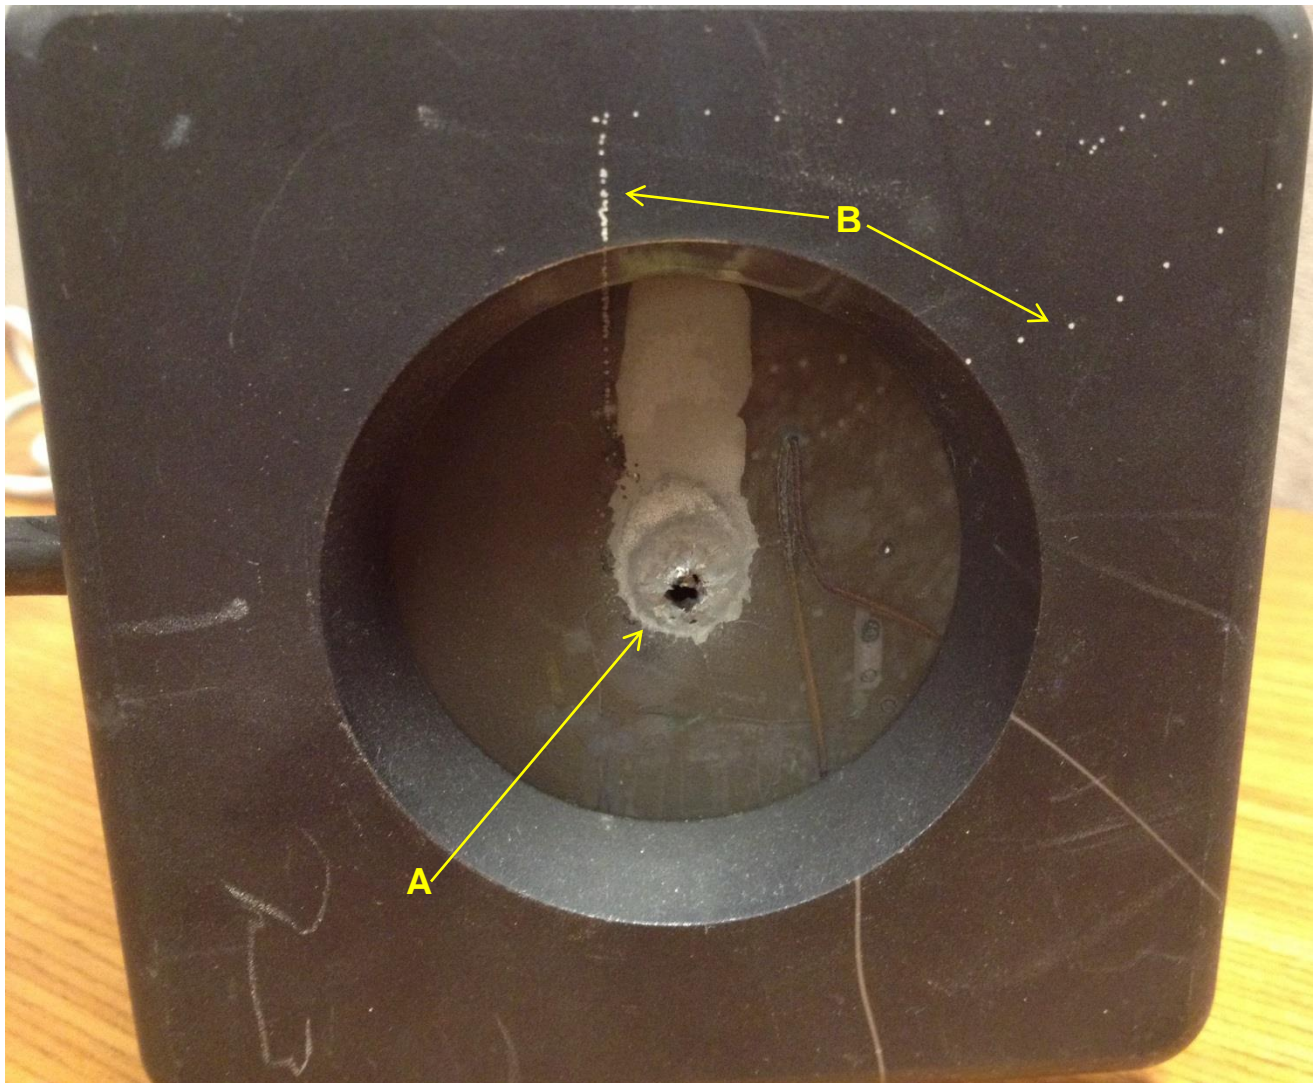
**Figure 6: Very Severe Damage Caused by Too High of a Total Power Level and Density**

- A. Example of a severely ablated and melted thermopile sensor rendered non-functional. The user most likely used too high of a total power level as well as too high of a power density, puncturing the middle of the sensor disk
- B. There are also a number of smaller marks around the housing and onto the sensor disk that would have been caused by a very tightly focused beam hitting the sensor. These marks did not cause the significant damage in the center of the sensor, but are a good indication that this sensor was not being used properly. These were most likely caused by a pulsed laser as the sensor was moved in and out of the beam path.

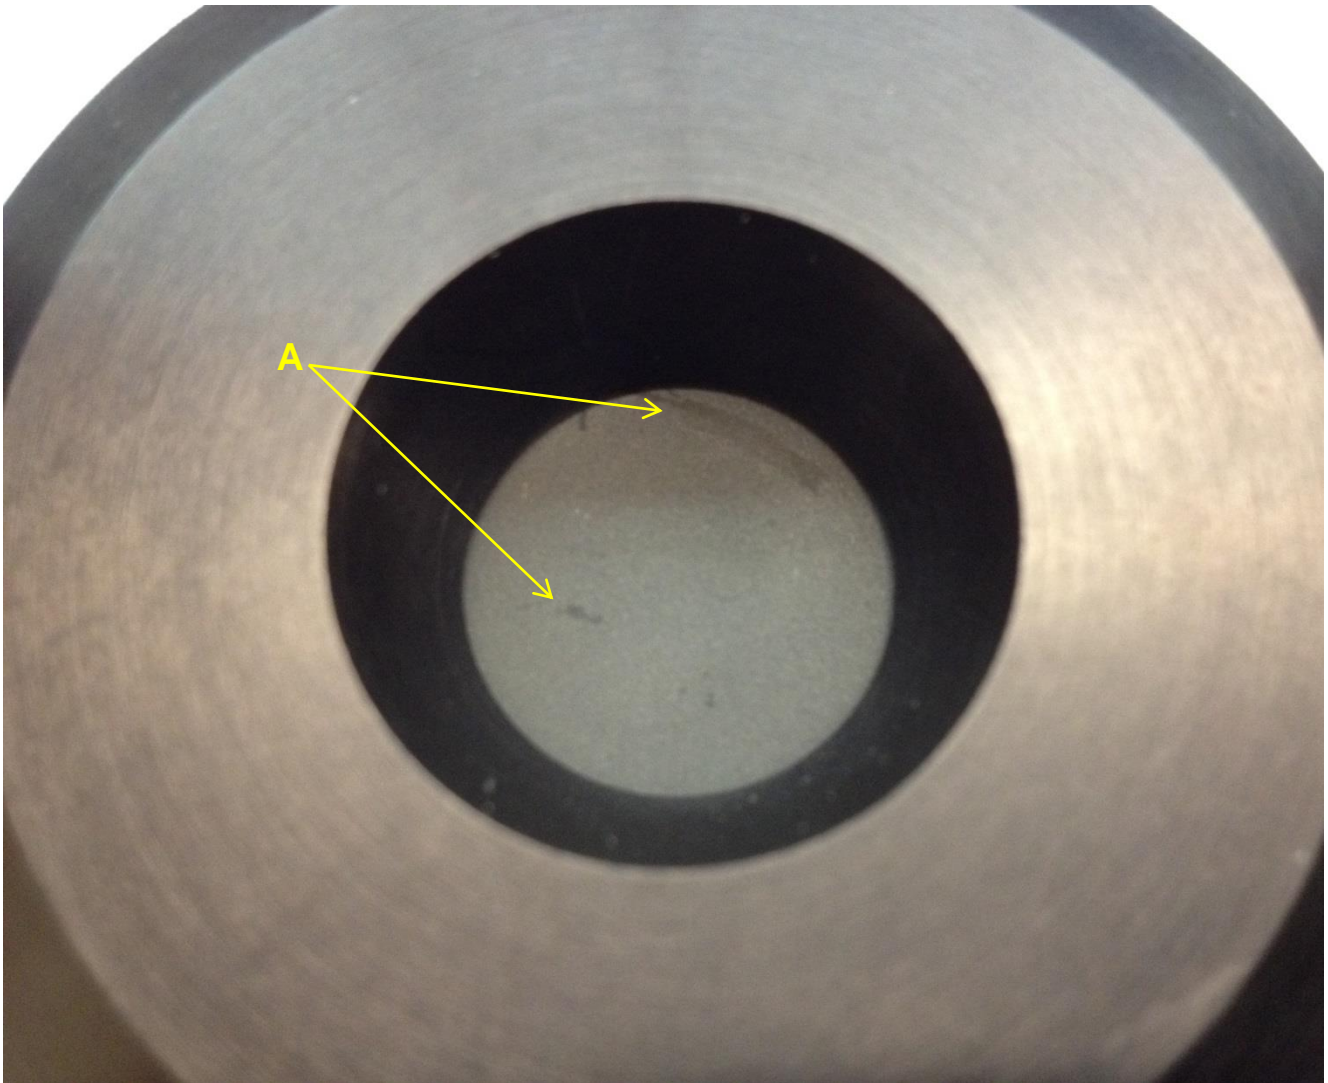
**Figure 7: Streaks on Thermopile Caused by Contamination**

This is an example of a sensor that has some marks on it that are most likely not affecting the performance of the product.

- A. The black streaks on this sensor surface were most likely caused by a small amount of grease or dirt that smeared across the sensor surface. Marks like this typically won't cause problems with a sensor, especially since they are not in the very center of the sensor area. There is a chance that marks can burn onto the sensor disk if a laser beam hits them. However, if the marks do not get larger or worse with time, a sensor in this condition will most likely continue to work properly and may not need a disk replacement during recalibration.

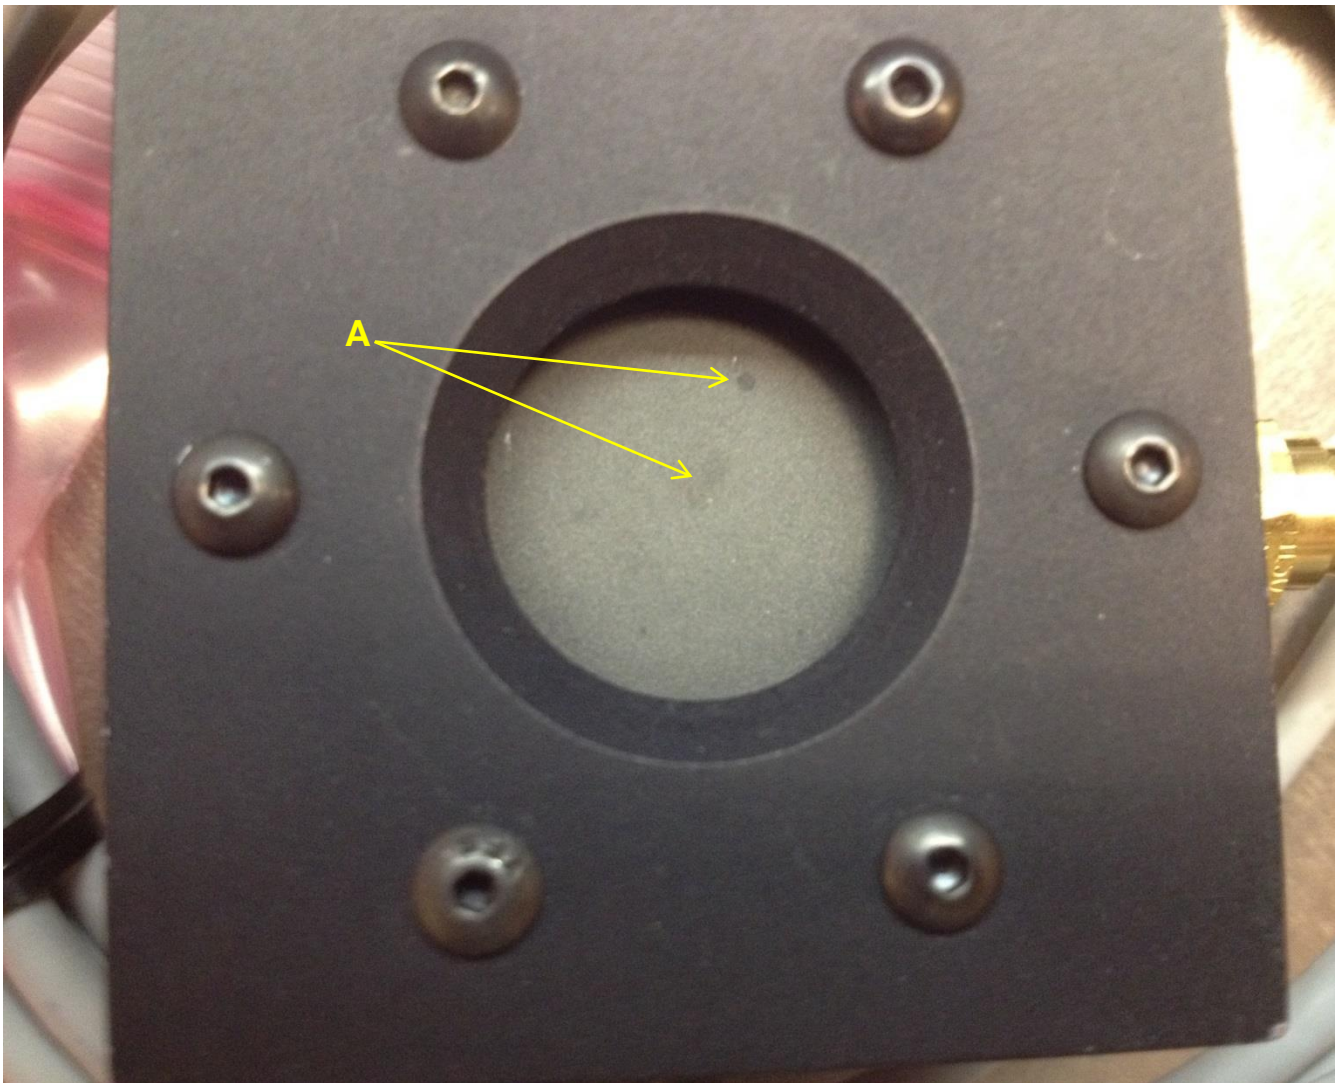
**Figure 8: Discoloration Due to Contamination**

- A. This is another case where there are some slight discolorations on the sensor surface most likely caused by small bits of contamination that got on the sensor disk. This type of discoloration is not severe enough to cause problems with the sensor's performance.

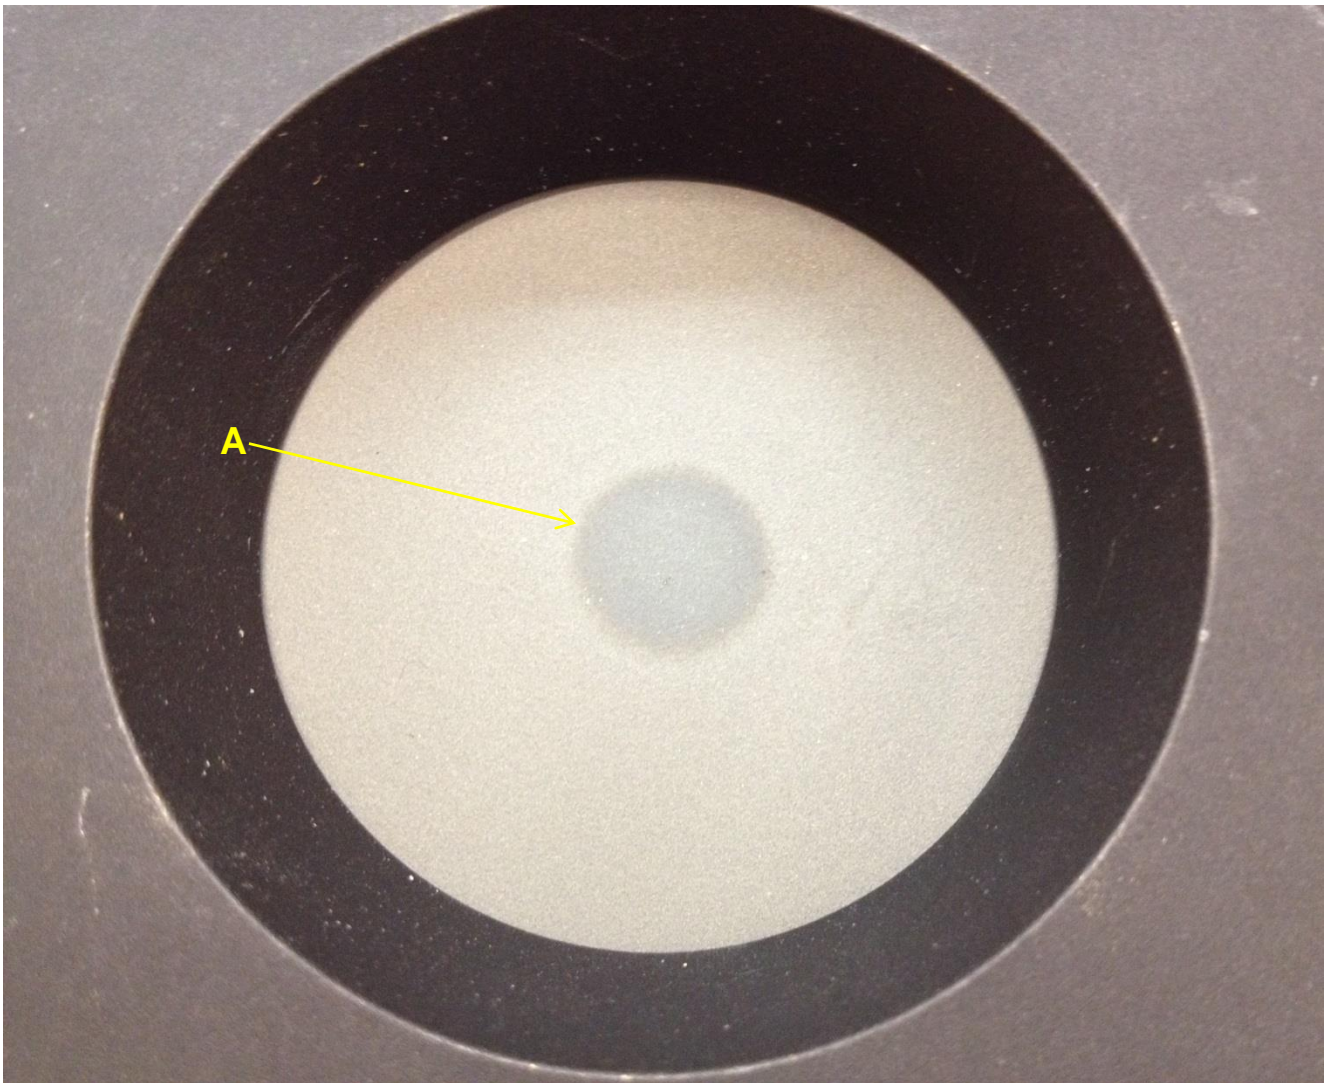
**Figure 9: kW Level Power Sensor near Its Damage Threshold**

This is a case specific to kW level power sensors such as the PM1K, PM5K and LM-5000 products.

- A. The discoloration in this area was definitely caused by a laser beam, although it is not to the point of melting, charring, or ablation yet. Some slight discoloration with the kW level sensors is somewhat normal just given the high amount of power that these sensors absorb. Therefore, a slightly lighter or darker spot similar to what is seen here isn't necessarily indicating that this has been damaged. This particular sensor technically has not been damaged yet. However, this discolored spot is starting to show a bit of a blue/green color to it, which means that the coating could be getting close to melting. If a spot like this shows up on the sensor, it would be recommended to take steps to reduce the power density that is being used on the sensor or to increase the water flow rate through the sensor to try and help keep it a bit cooler during measurements.

It is very important to understand the damage threshold and water-cooling requirements for kW sensor products. A water flow requirements note and kW damage threshold note have been created for these products, which should both be reviewed prior to using one of these kW level sensors. To learn more about water-cooling requirements for kW sensor products, read our [applications note](#).

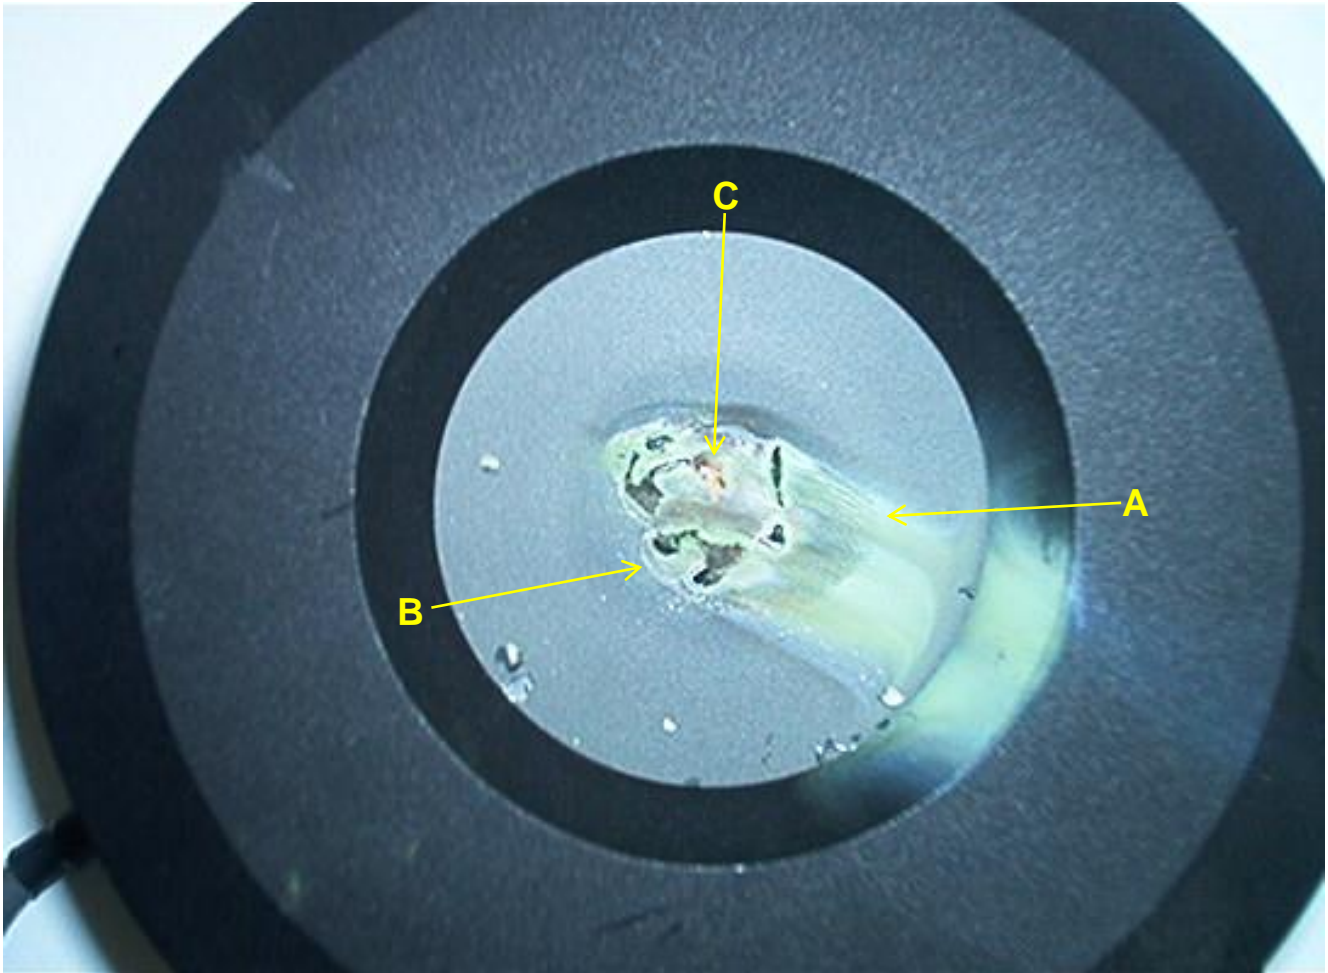
**Figure 10: Significant Damage to kW Level Power Sensor Due to Too High of a Power Density or Insufficient Water-Cooling**

- A. In this area a green color is present which indicates that the sensor coating has melted. In addition, there is green smoke in this damaged region.
- B. Black charring marks are present in this area.
- C. The copper thermopile disk is exposed near the center of the sensor

This sensor is an extreme case, but illustrates key things to watch for on the kW level sensors. Any time that a green melted spot, black charring, or exposed metal show up, the sensor has been significantly damaged and should not continue to be used in that condition. Damage like this can be the result of too high of a power density or from the sensor getting too hot, like what can happen without sufficient water-cooling.
